California State Board of Equalization
450 N Street, Sacramento, California

Mold Remediation – 7th Floor
Closure Report Addendum (Revised)
Project No. 2372.02-572

Closure Report Date: August 10, 2010
Addendum Date: October 31, 2012
Addendum Revision Date: January 9, 2013

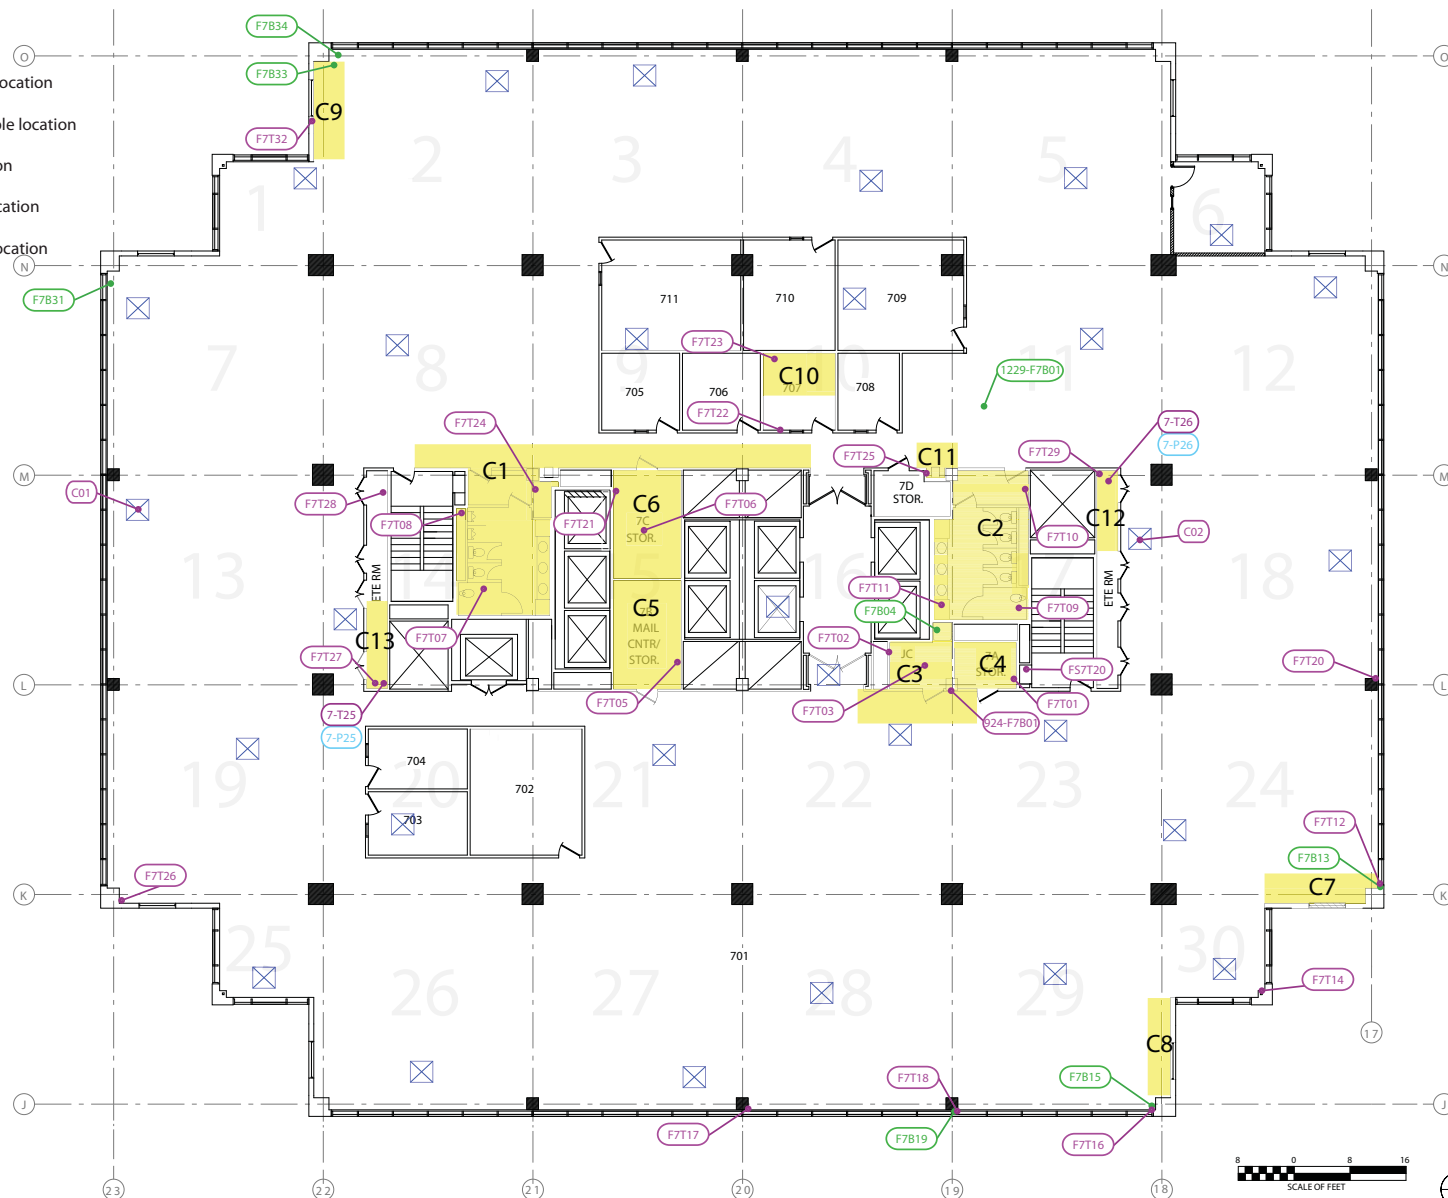
Subsequent to the completion of the closure report, a need for additional investigation and/or remediation activities was identified. Identified areas were subjected to sampling. Using a combination of surface tape lift and/or bulk samples, LCD tested stains on walls and other building materials to determine if the stains were indicative of mold growth. The sample locations are depicted in a revised Figure 2 attached to this addendum.

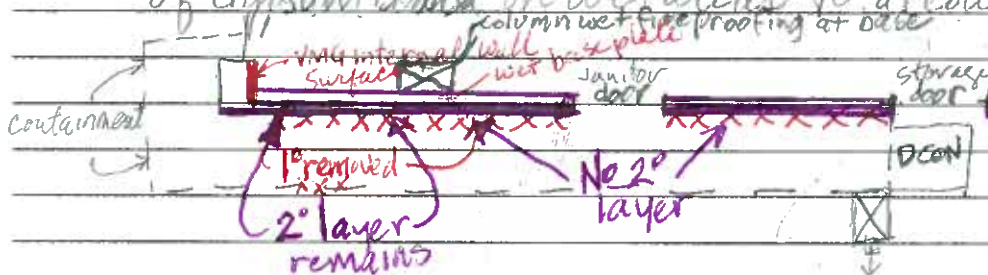
22:00 requires containment to open suspect walls (all core walls)

22:30 continue scraping adhesive and prepare to work
in containment. remove core base and first layer
of Gypsum Board on wet areas to allow drying of 2nd layer

23:00 cleanup/barout and detail cleaning in containment
carpet tiles are dry - begin apply new adhesive to concrete
allow adhesive to cure prior to installing floor tile.

00:00 Seal wall cavities in containment -

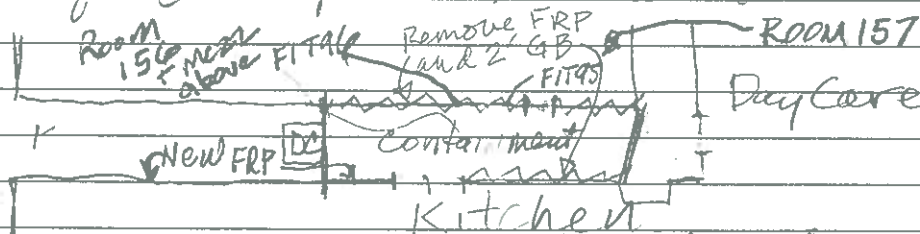
21150 Break - No stains in North wall cavity, 2 minor stains SW wall cavity
